27 KEPCO MANGILAO SOLAR, LLC and  
28 SAMSUNG E&C AMERICA, INC.,

)  
) DECLARATION OF COUNSEL FOR  
) DEFENDANT SAMSUNG E&C  
) AMERICA, INC. RE: MOTION FOR  
) JUDGMENT ON THE PLEADINGS

**Subject: Notice of Violation / Compliance Order / Penalty Order**

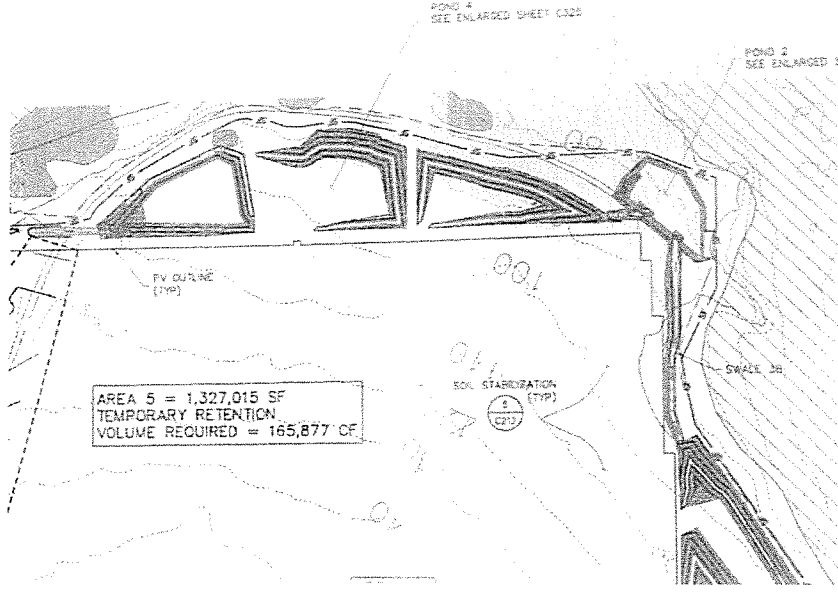
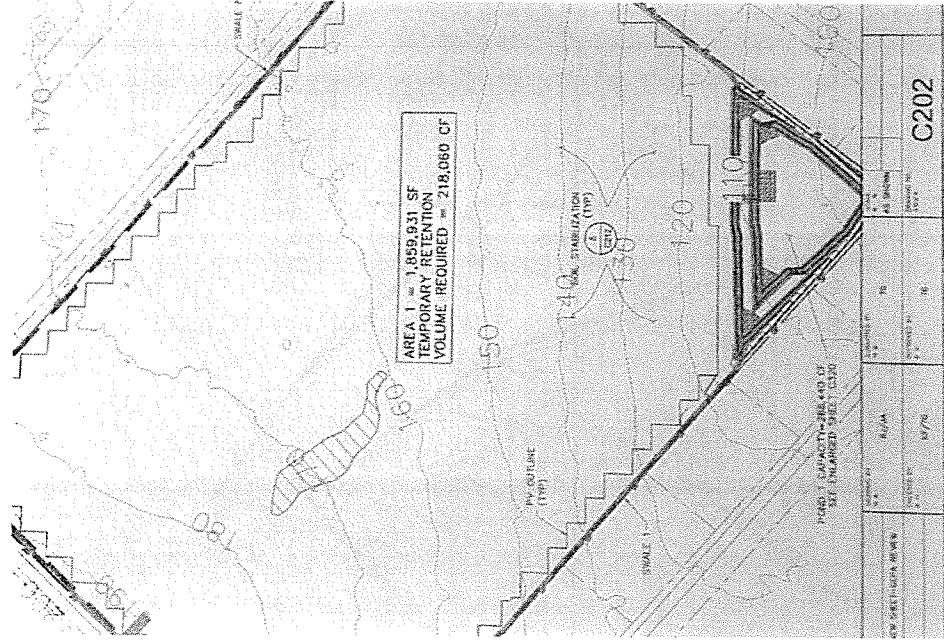
From the aerial images I noted that the location of Pond 4 appeared to coincide with the location of the project offices. Mr. Kim and staff confirmed that Pond 4 had not been constructed yet, and that the project offices were indeed located in the same spot. I also noted that construction of Ponds 1 and 3 appeared to still be underway. This was also confirmed by Mr. Kim and others that were present.

Site aerial image taken July 22, compared to approved E&SC plans (revised plan approved July 2020 in center), showing location of office at Pond 4 site (July 23, 2021)

- I strongly recommended that Samsung begin construction of Pond 4, at the very least the lower sections of the pond where the office is not located, to prevent further discharge.

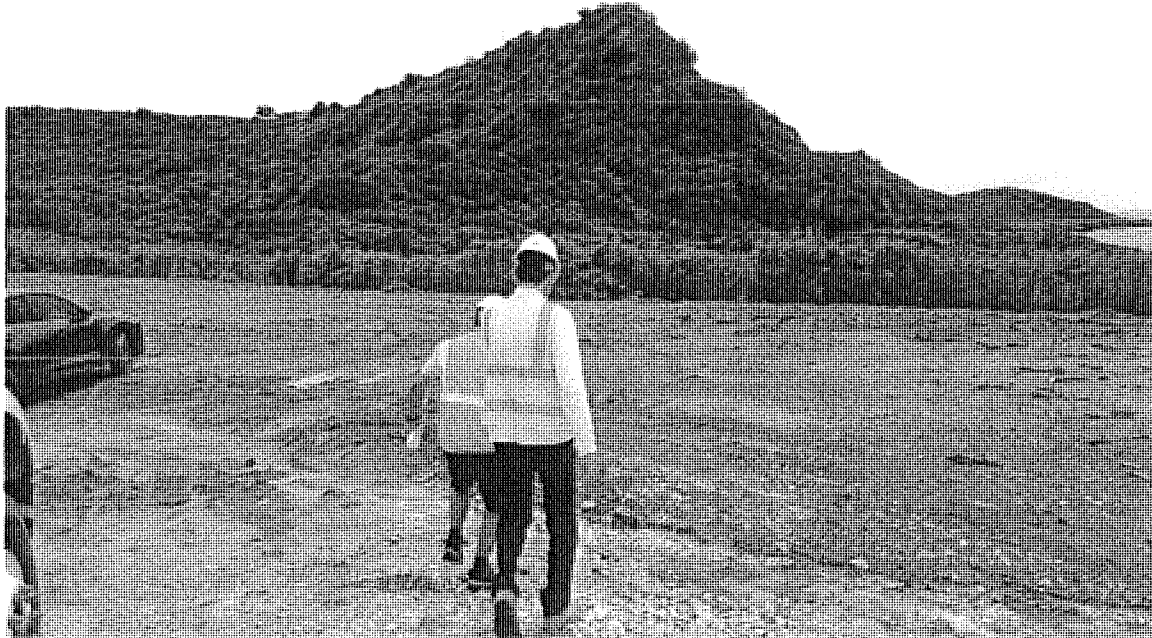
View looking from site office to area where start of Pond 4 berm and swale should be located.  
(July 23, 2021)

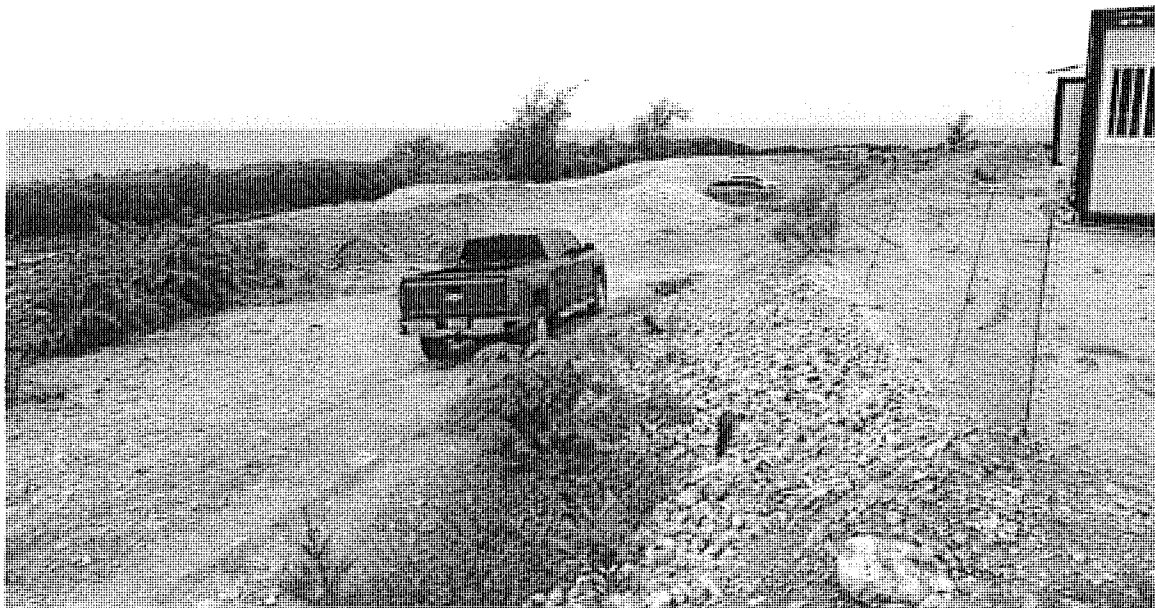
We then set out to inspect the area of Ponds 4 and 2 by foot. Pond 4 had not been constructed, but the beginnings of the earthworks berm that would form the lower portions of the ponds were present, but not complete. I observed evidence of a large discharge of runoff from the area toward the fence, and a single line of silt fence that had been buried by accumulated sediment. The Samsung staff present confirmed that this was the location of the complaint from the neighbors. This discharge was located in the area where Pond 4 was supposed to have been built, and I pointed out that if it had been built as per the plan, the discharge to the neighbor's property would likely not have happened. We then walked further down slope to Pond 2, which had been built and was full of water and sediment, although the surrounding berm did not look finished and I did not get an affirmative answer if the pond was final or still in progress.

View looking downslope where Pond 4 berm construction has begun, and toward Pond 2 in distance. (July 23, 2021)

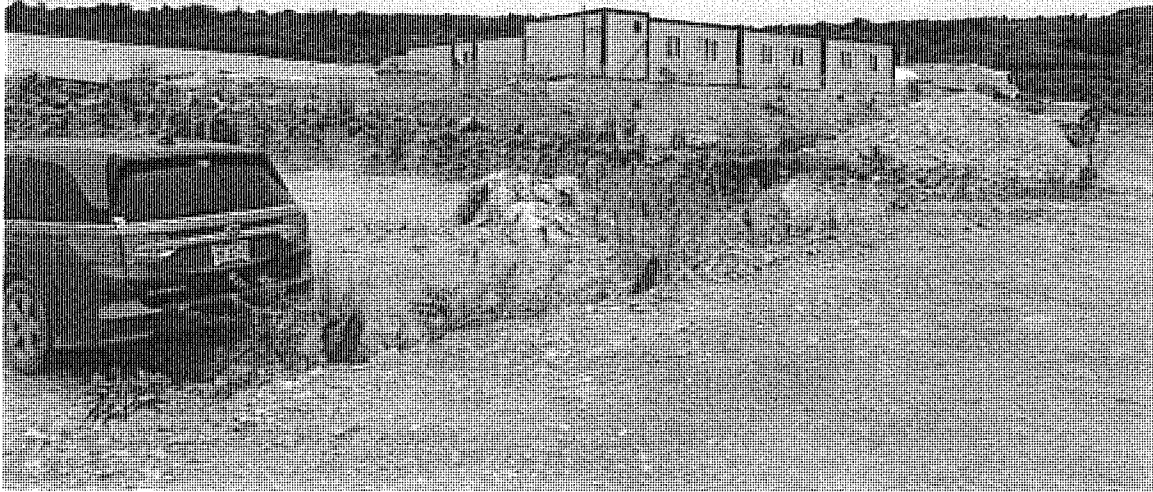
Looking back upslope toward Project Site Office, showing start of (revised) Pond 4 excavation (July 23, 2021)

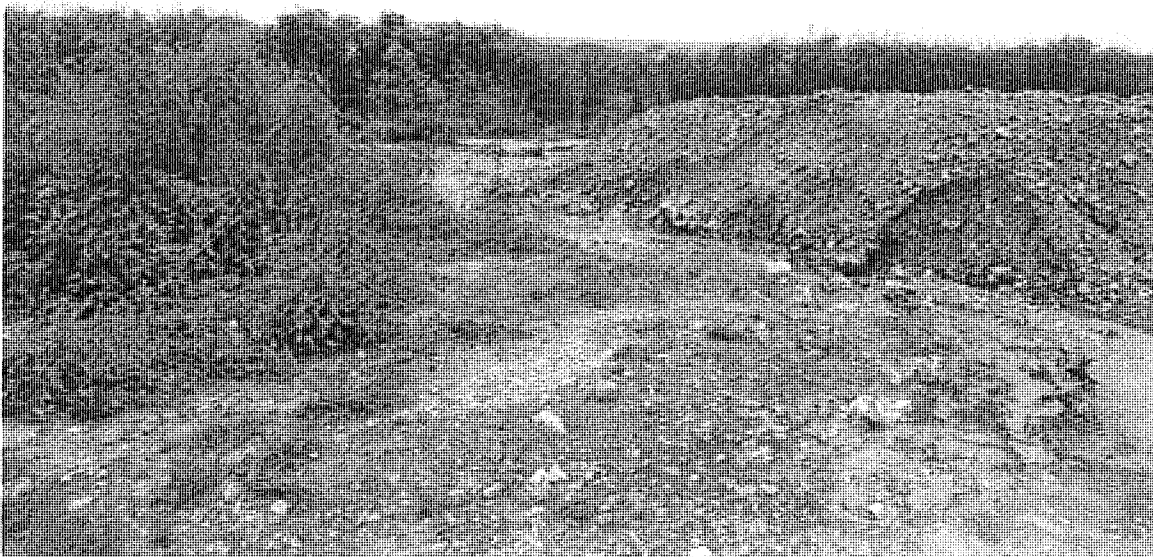
Location of discharge from Pond 4 area to off-site. This is reportedly the location of the complaint. See next page for close up. (July 23, 2021)

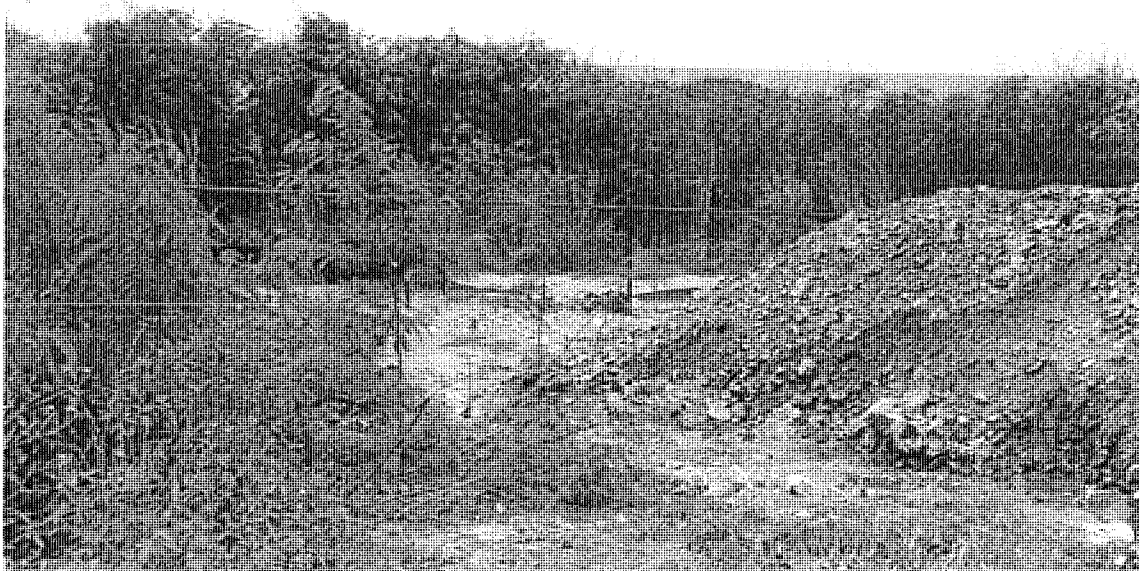
Close up of Pond 4 discharge location. Note accumulated sediment in delta-pattern, and overwhelmed silt fence. (July 23, 2021)

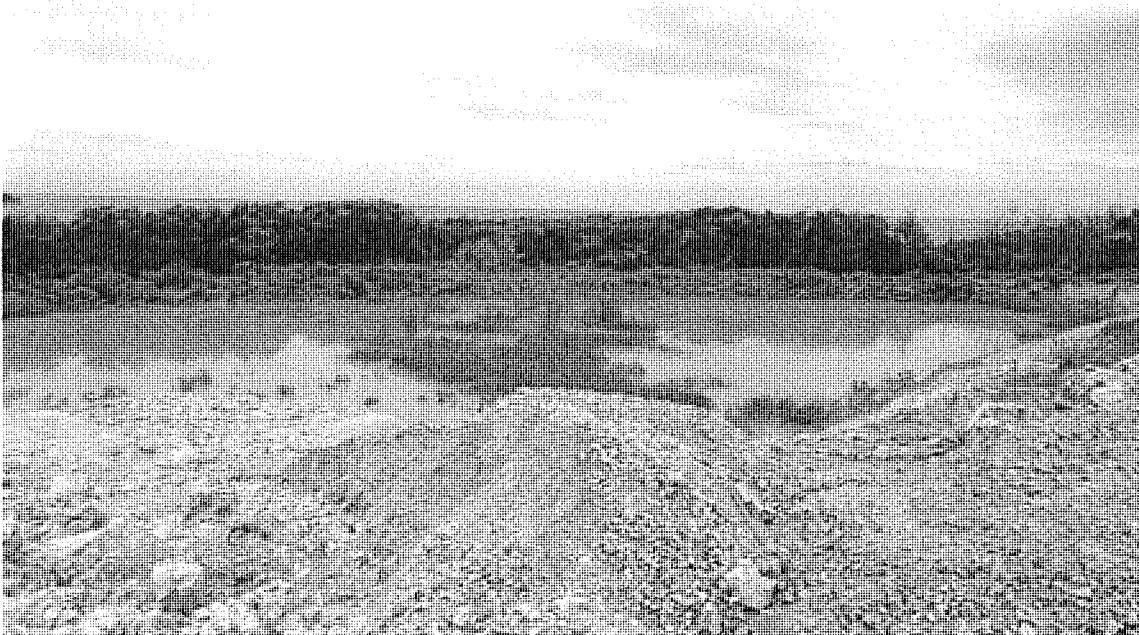
Pond 2, with accumulated runoff and sediment from storm. This pond does not appear to be finished. (July 23, 2021)

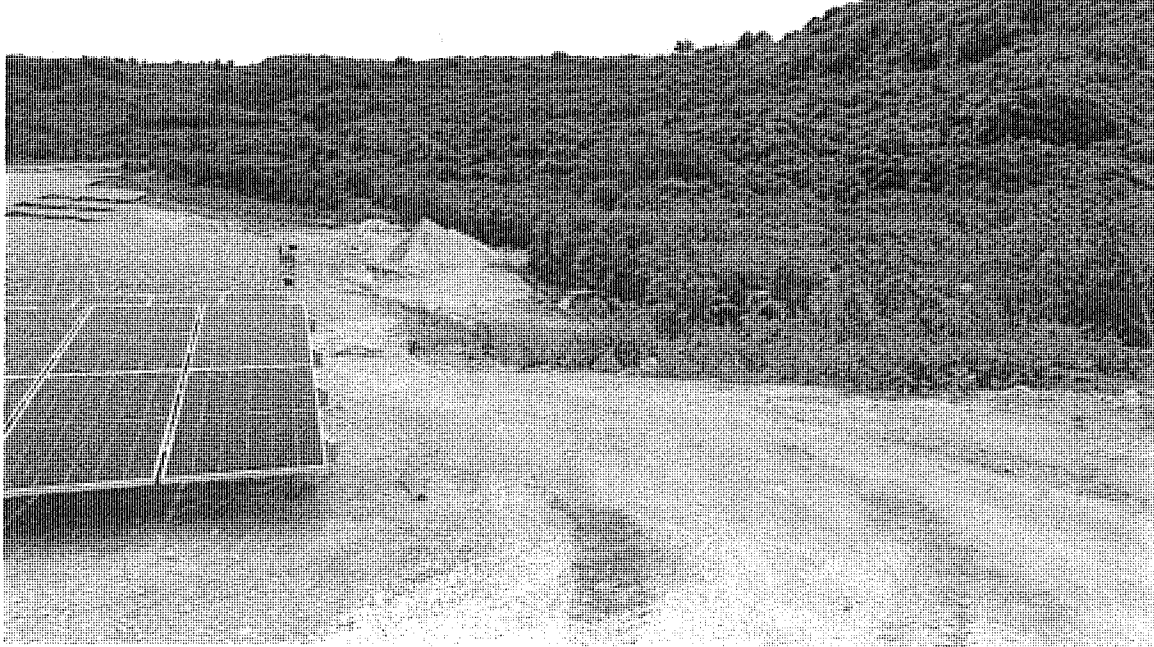
We then drove through the project site to visit Ponds 1 and 3. On the way I stopped and took pictures of an area where evidence of a large discharge of runoff was present. This area does not appear to be served by a sedimentation basin (pond) in the approved E&SC plans, and is directly upstream of Marbo Cave according to the site plans. On the way between Ponds 3 and 1, I observed that the perimeter swale had a large number of ironwood saplings growing in it, as well as a lot of sediment that was obstructing the cross section of the swale. (See addendum below – Pond 5 was added to the site E&SC plans and approved by GEPA on January 4, 2021. I inspected with Johnny Abedania on July 28, 2021 to further investigate).

Location of apparent discharge toward Marbo Cave. See next photo for close-up. (July 23, 2021)

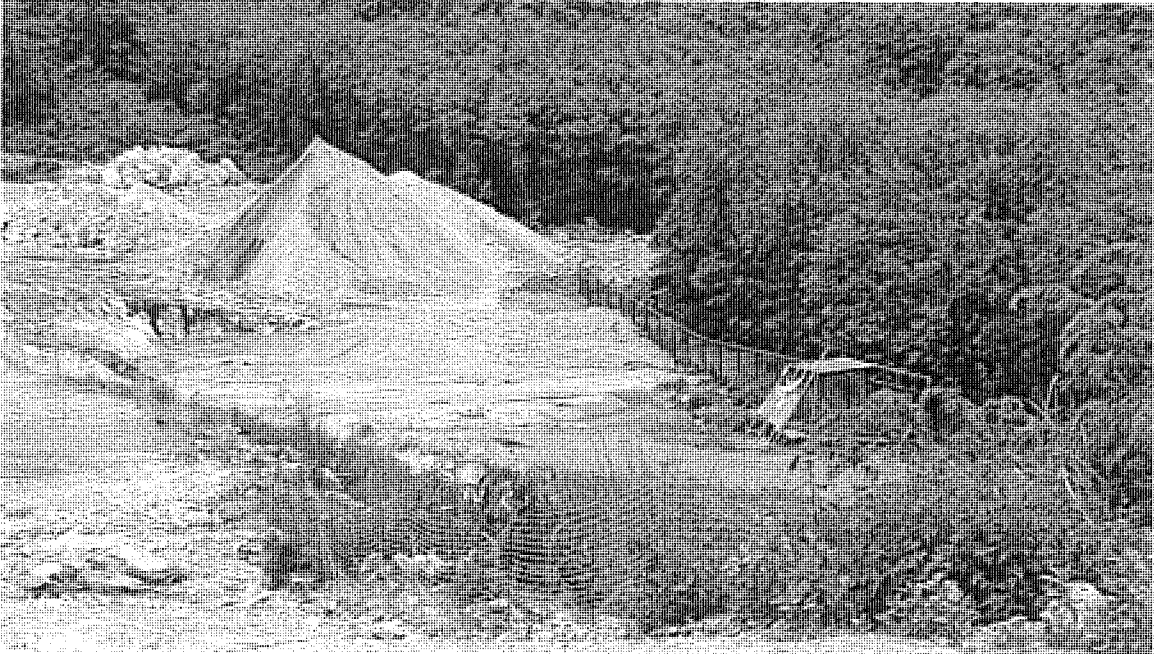
Close-up of area that appears to be a large, unprotected off-site discharge toward Marbo Cave area. Note large delta-type formation of sediments, indicating long-term history of discharge. (July 23, 2021)

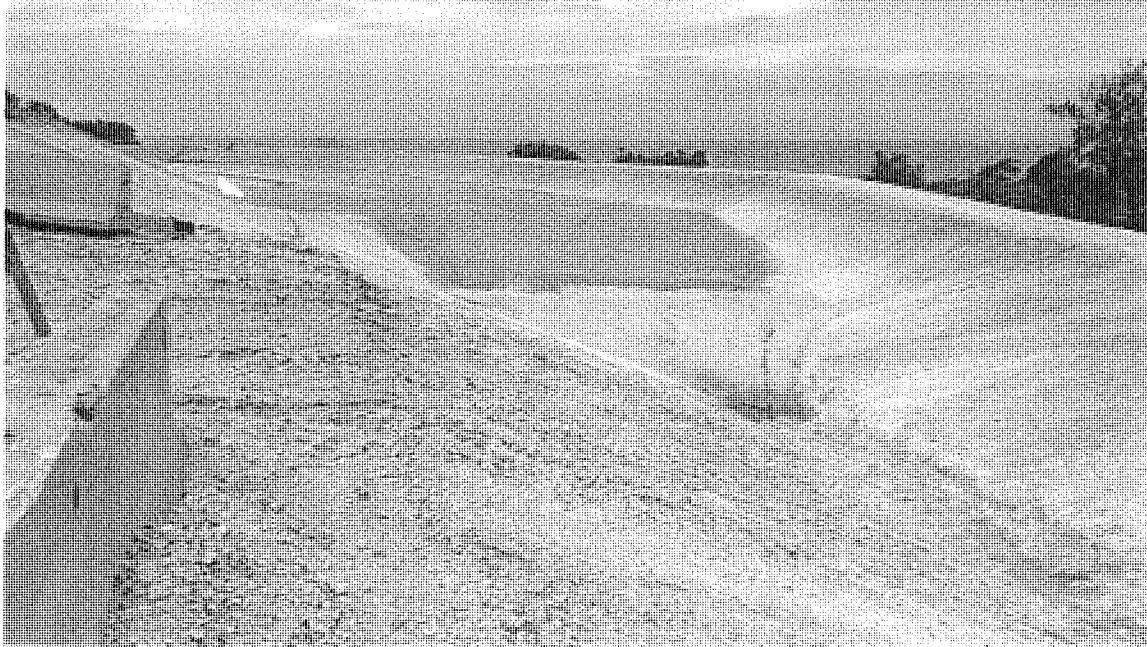
Pond 3 was mostly in place but according to Mr. Kim it was not yet finished; the stone overflow structure still needed to be built. We observed that runoff had only filled Pond 3 about a foot or two. Pond 1 was complete, according to Mr. Kim. We observed that runoff had filled Pond 3 almost to the point of overflowing, by evidence of a clearly visible high water mark. However Mr. Kim stated that it had not overflowed. We observed that there were several stockpiles of material in Pond 1 that served to reduce its capacity to hold runoff. We also observed that a large amount of sediment had accumulated in Pond 3, and discussed the need for maintenance to remove it periodically, and completely once the site was stabilized with vegetation, to ensure that the pond worked as an infiltration basin post-construction.

Pond 3. Overflow weir in distance is not yet finished – still requires stone riprap. (July 23, 2021)

2. **Within fourteen (14) days of receipt of this order:**
  - a. Submit to GEPA a revised design which includes an armored overflow weir from Pond 1, similar to that provided for Pond 3, to prevent the failure of the pond embankment in the event of an overtopping storm event.

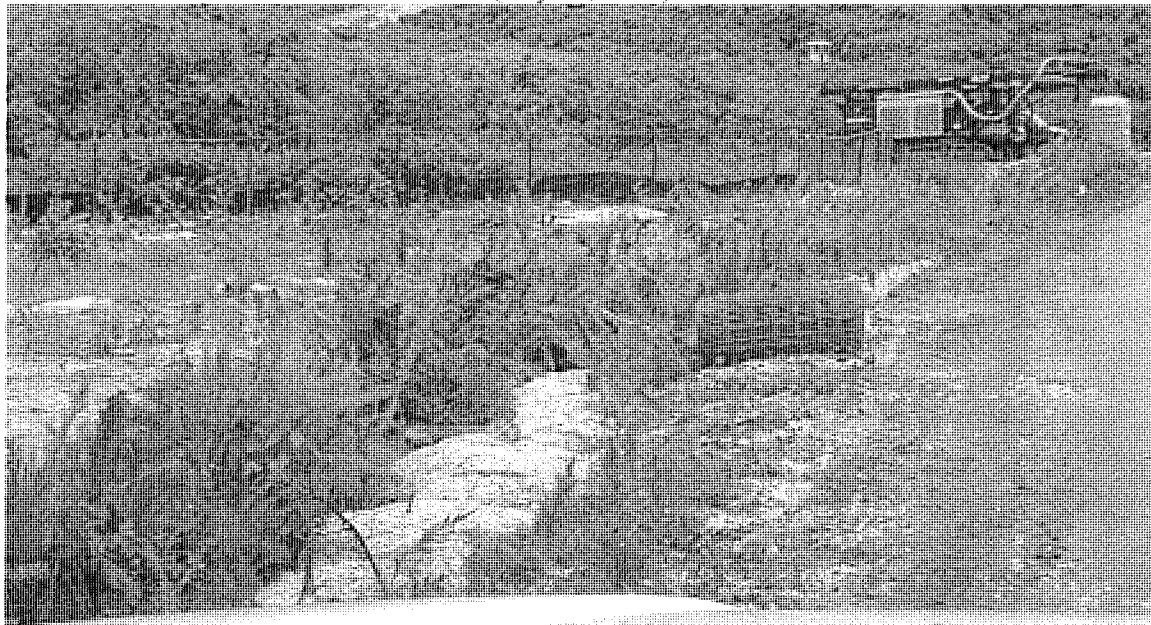
Perimeter berm which conveys runoff to Pond 3. Ironwood saplings and a large amount of accumulated sediment obstruct the flow. (July 23, 2021)

- I recommended that the ironwood saplings seen growing in the perimeter swales be removed as soon as possible, otherwise they would block the flow of water and potentially cause discharge of runoff off-site, instead of to the approved ponds.

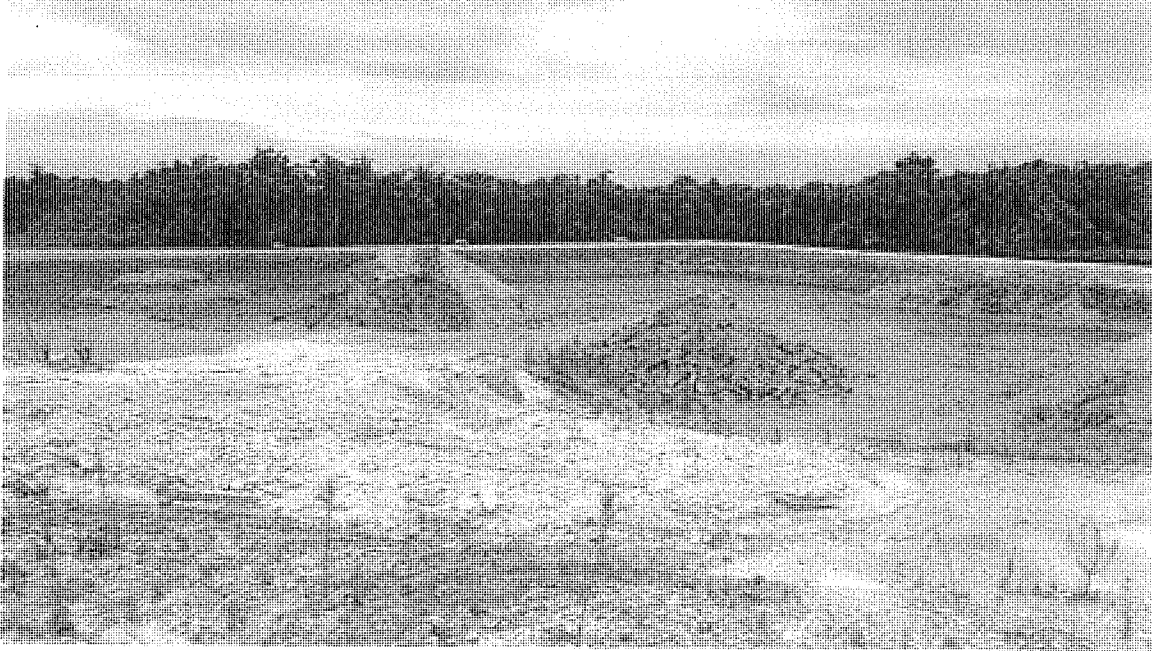
Pond 1. Note stockpiles of earth material, which reduce pond capacity. Also note high water mark from the previous storms. (July 23, 2021)

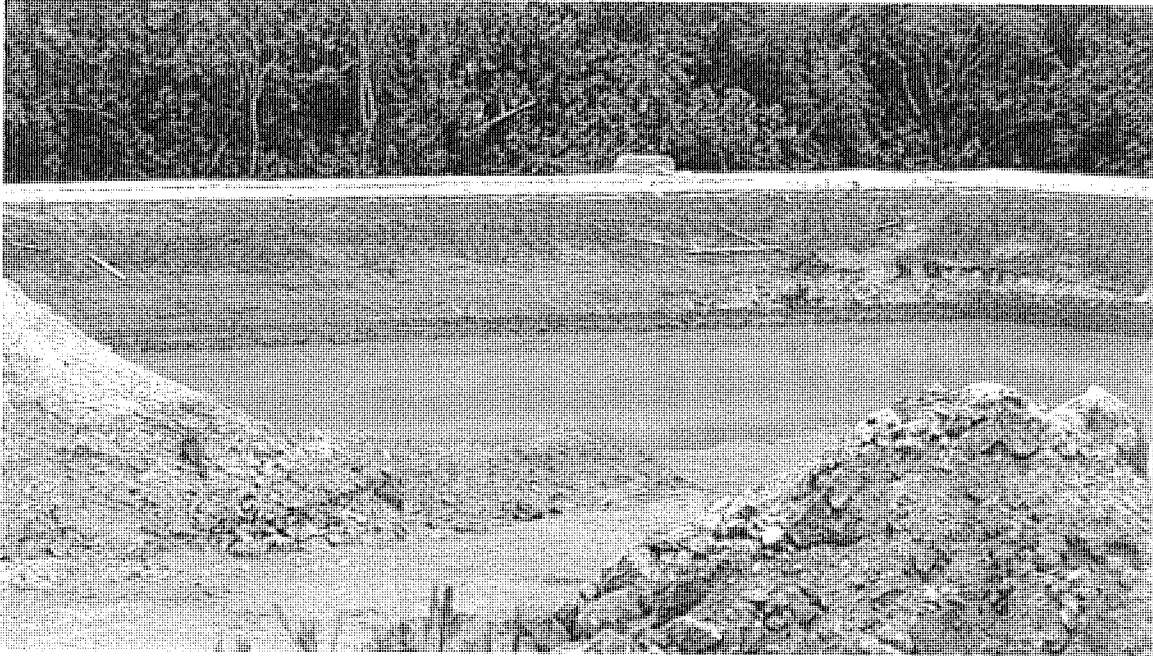
Close up of Pond 1 rim, showing high water mark indicating near-overtopping from prior storm. (July 23, 2021)

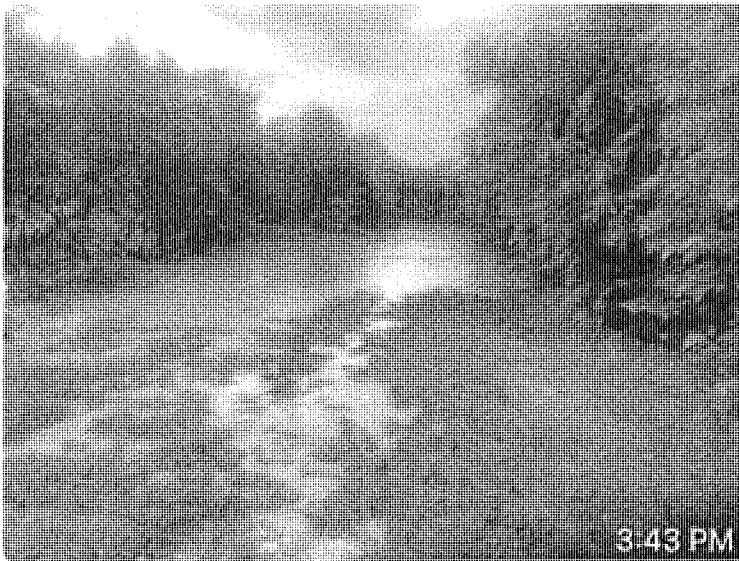
Images received over social media with original complaint. Bottom image purports to show sediment plume in ocean, originating from Samsung Mangilao Solar Project. (July 23, 2021)

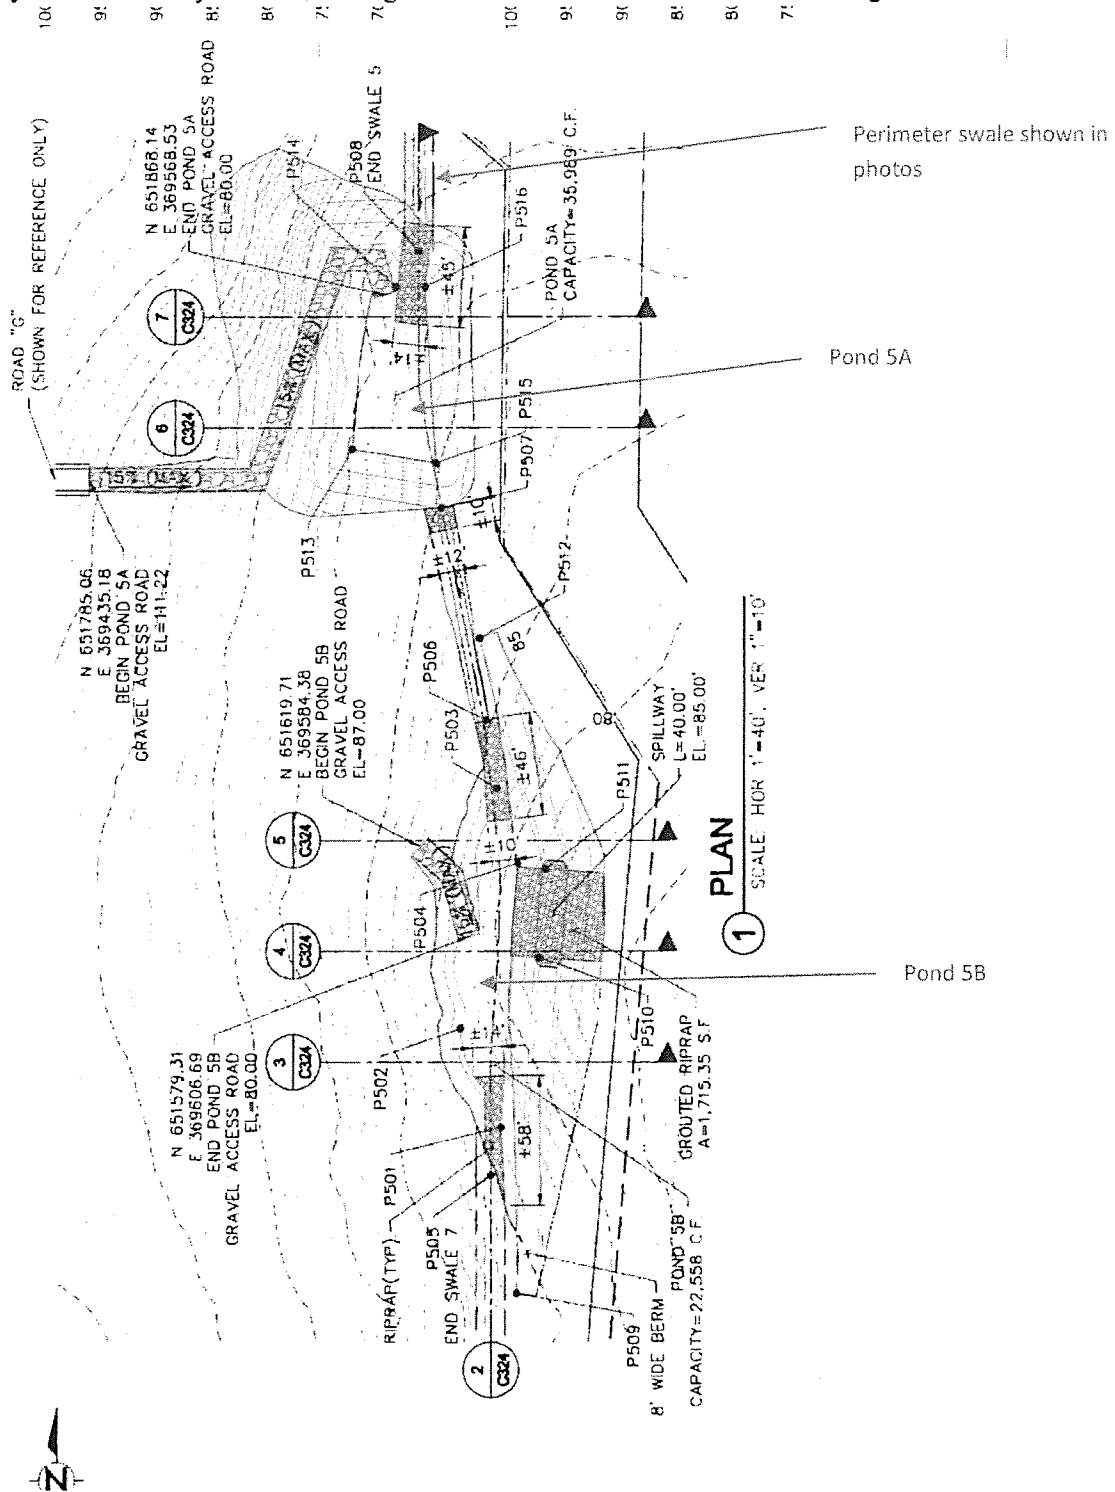
ADDENDUM: Inspection of Pond 5, July 28, 2021. Excerpt from revised E&SC plans approved by GEPA January 4, 2021, adding Pond 5 to the area which would discharge toward Marbo Cave:

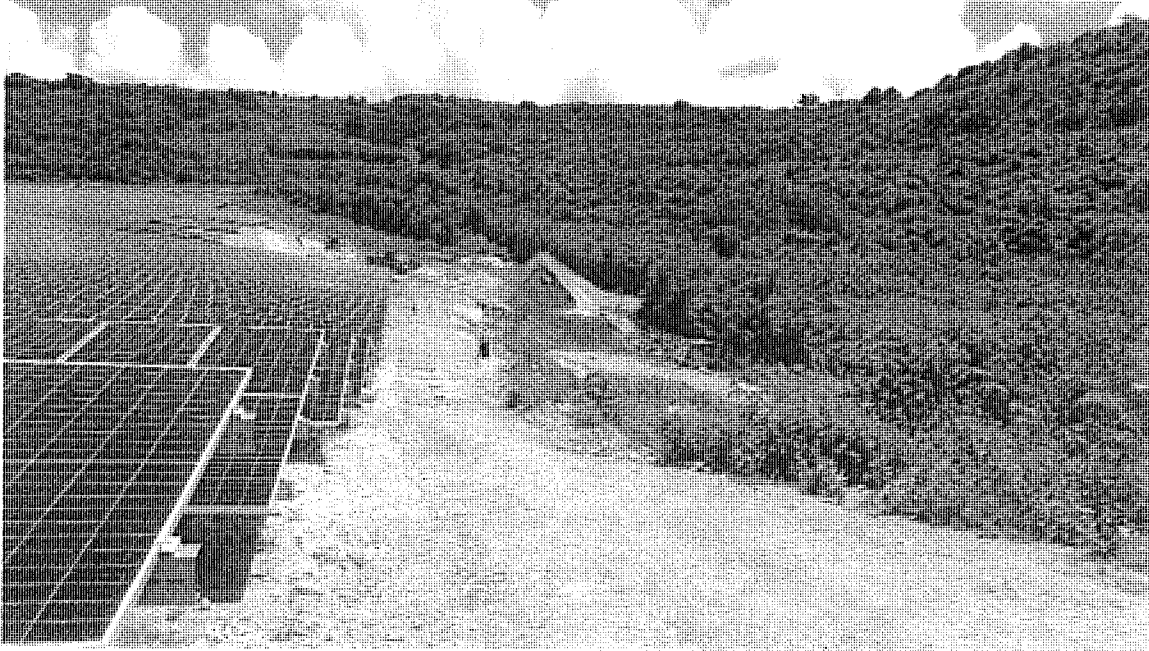
The location of the Marbo Cave discharge and Pond 5, showing activity underway to install E&SC measures on July 28, 2021:

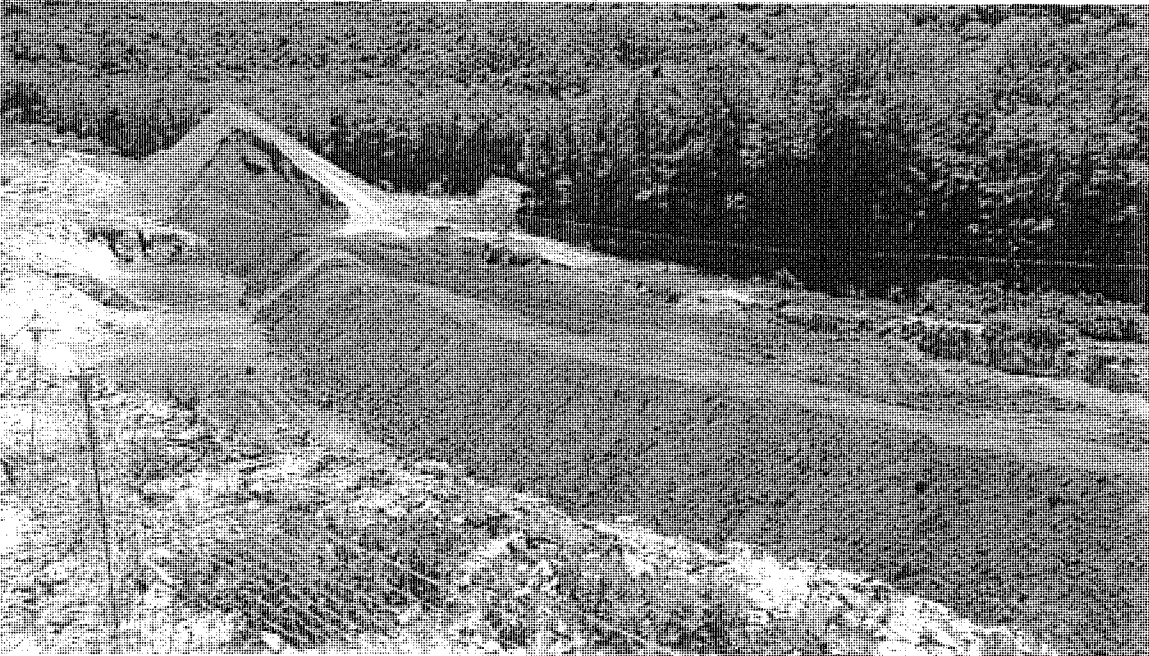
The beginning of construction work for Pond 5B. The soil embankment is to delineate a temporary storage pond, while the permanent embankment is installed just beyond (to the right). Base preparation for the permanent embankment has begun, but emplacement and compaction of embankment fill had not yet begun (July 28, 2021):

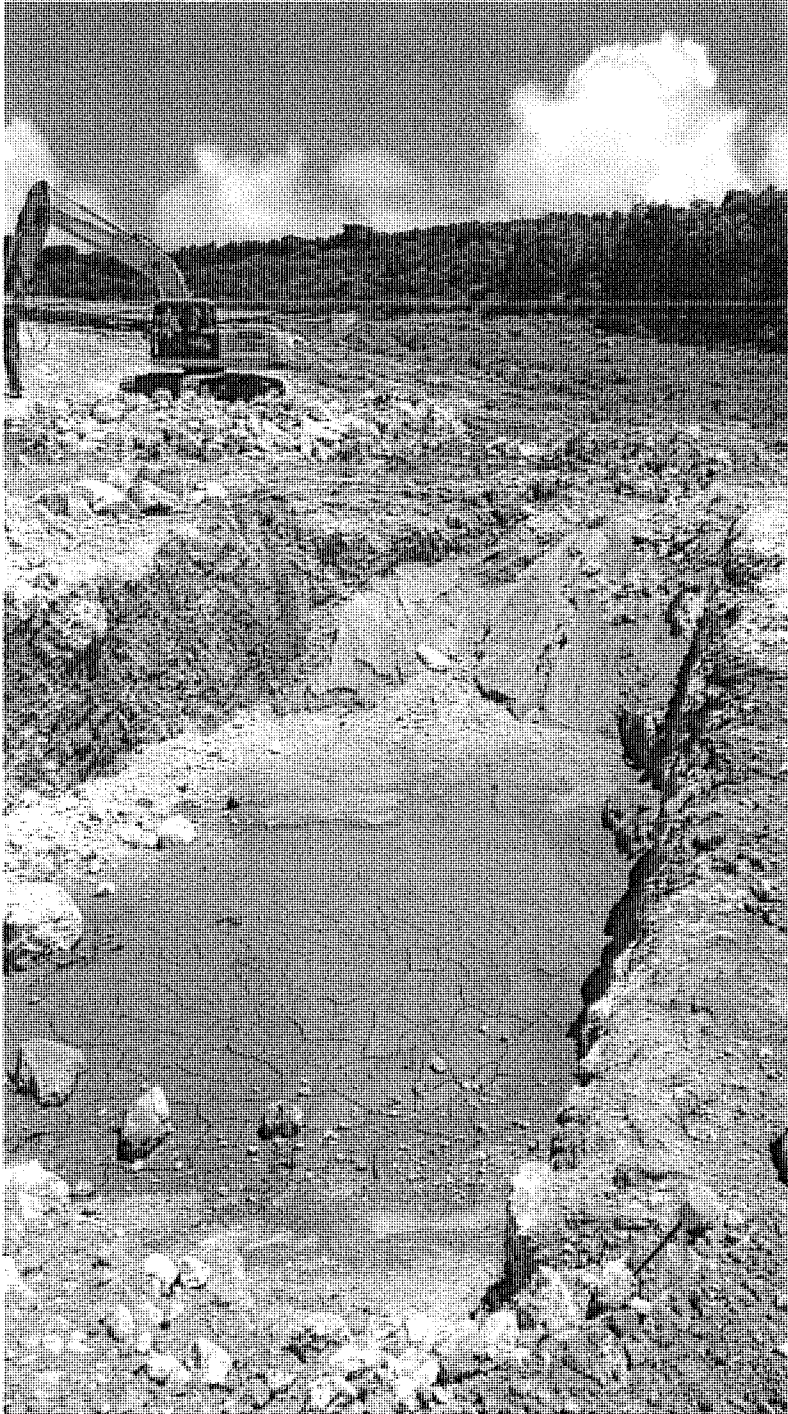
Pond 5A excavation, which according to Samsung site personnel was begun in June. However the excavation is not yet connected to the site swale, so mass runoff is unable to enter the basin. Sedimentation pictured is from incidental runoff that the excavation collected due to its location (July 28, 2021):

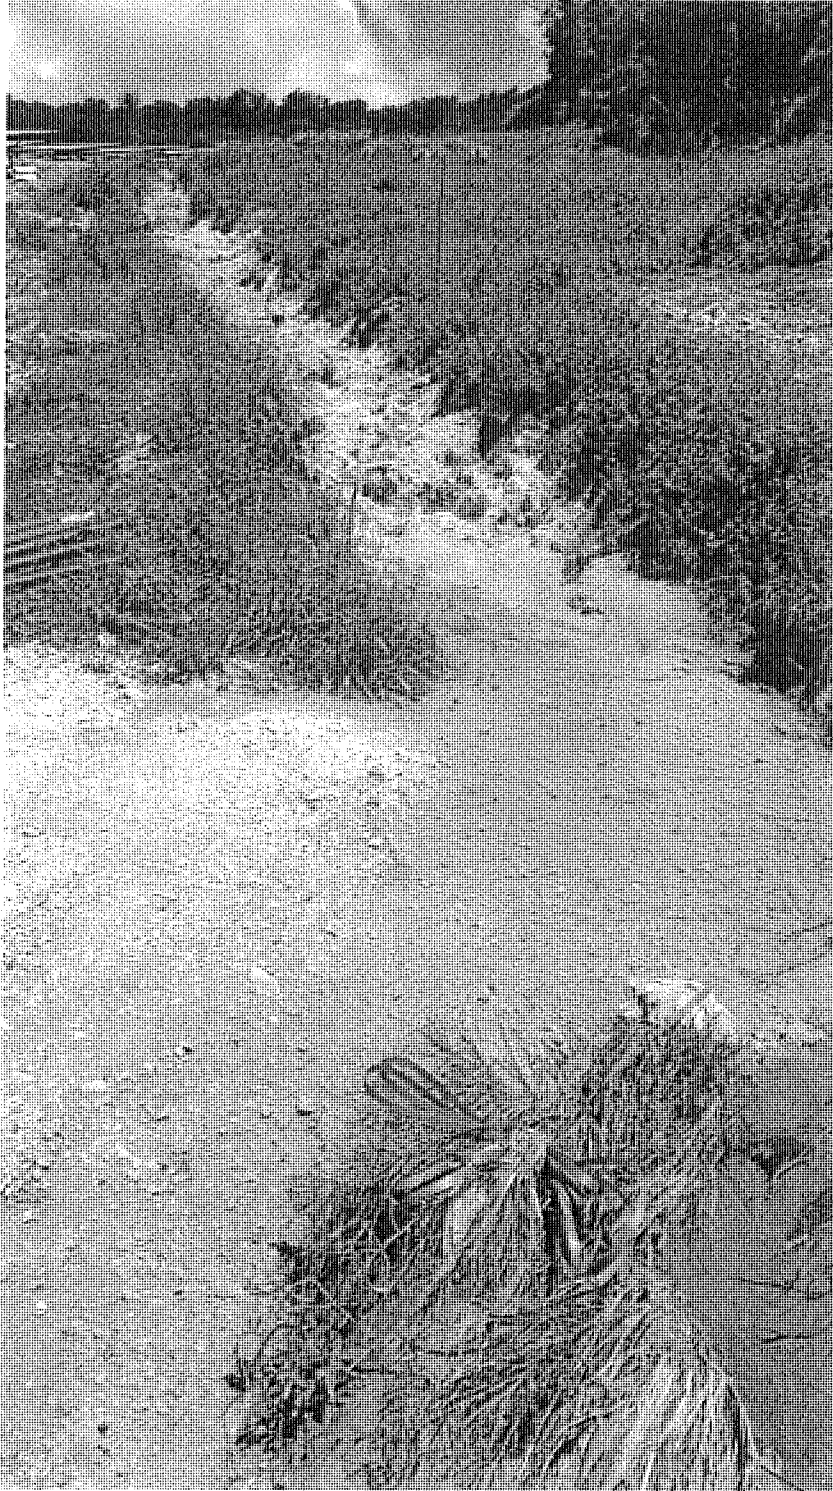
The perimeter swale which would discharge to Pond 5, but at the time of inspection it was not connected and sedimentation patterns showed that runoff discharged off-site (July 28, 2021)

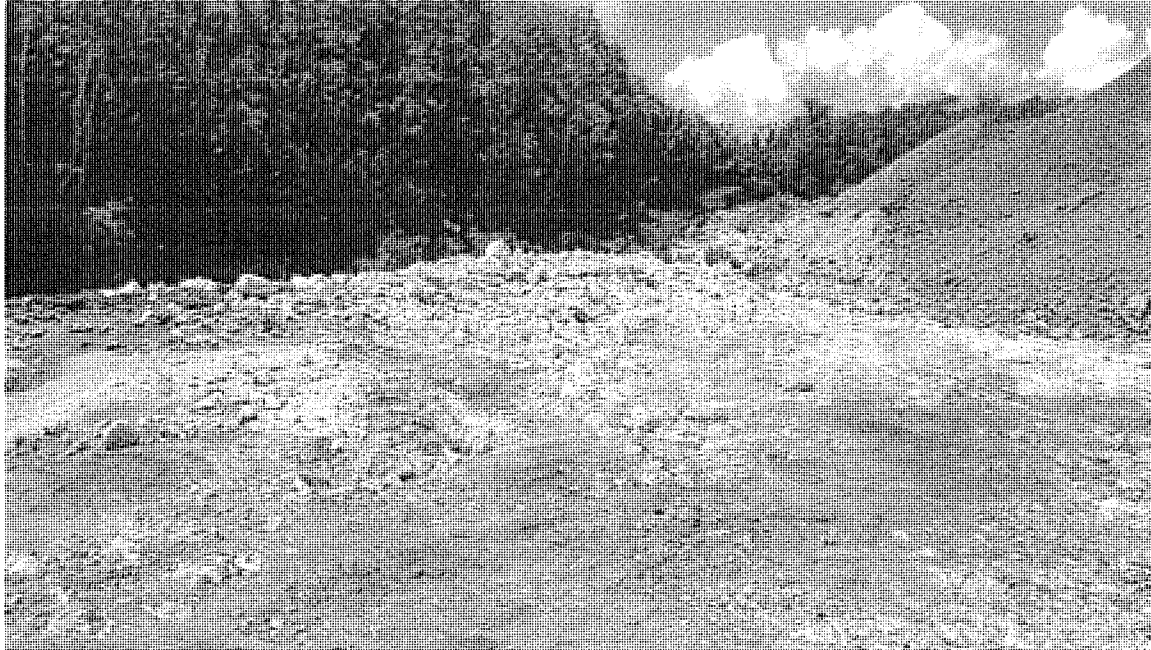
We observed that the perimeter swale had discharged to the open ground near the fence, and along with the surface runoff from the surround project area, had left a very large alluvial/delta formation of sediments, up to and including rocks around 1 to 2 feet in diameter. The deposited sediments could be seen extending into the forest far past the site boundaries, toward the Marbo Cave area.

This is the area where the perimeter swale currently discharges. A large delta-type (alluvial) formation of sediment is evident, showing that a large volume of runoff discharged off-site during the recent rainfall events (July 28, 2021).

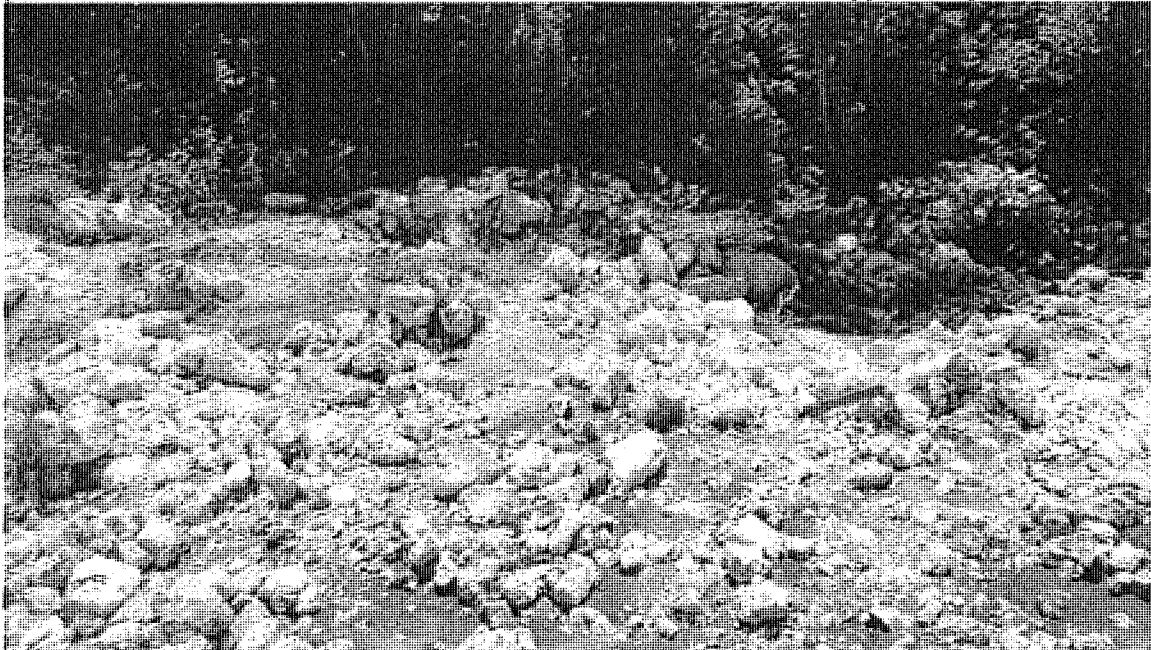
A view of the sediment discharged off-site during the recent rainfall events. The size of the deposited rocks demonstrates that flow volumes and velocities were very high. The top of the perimeter silt fence can be seen, where it was knocked down and overtopped. (July 28, 2021)

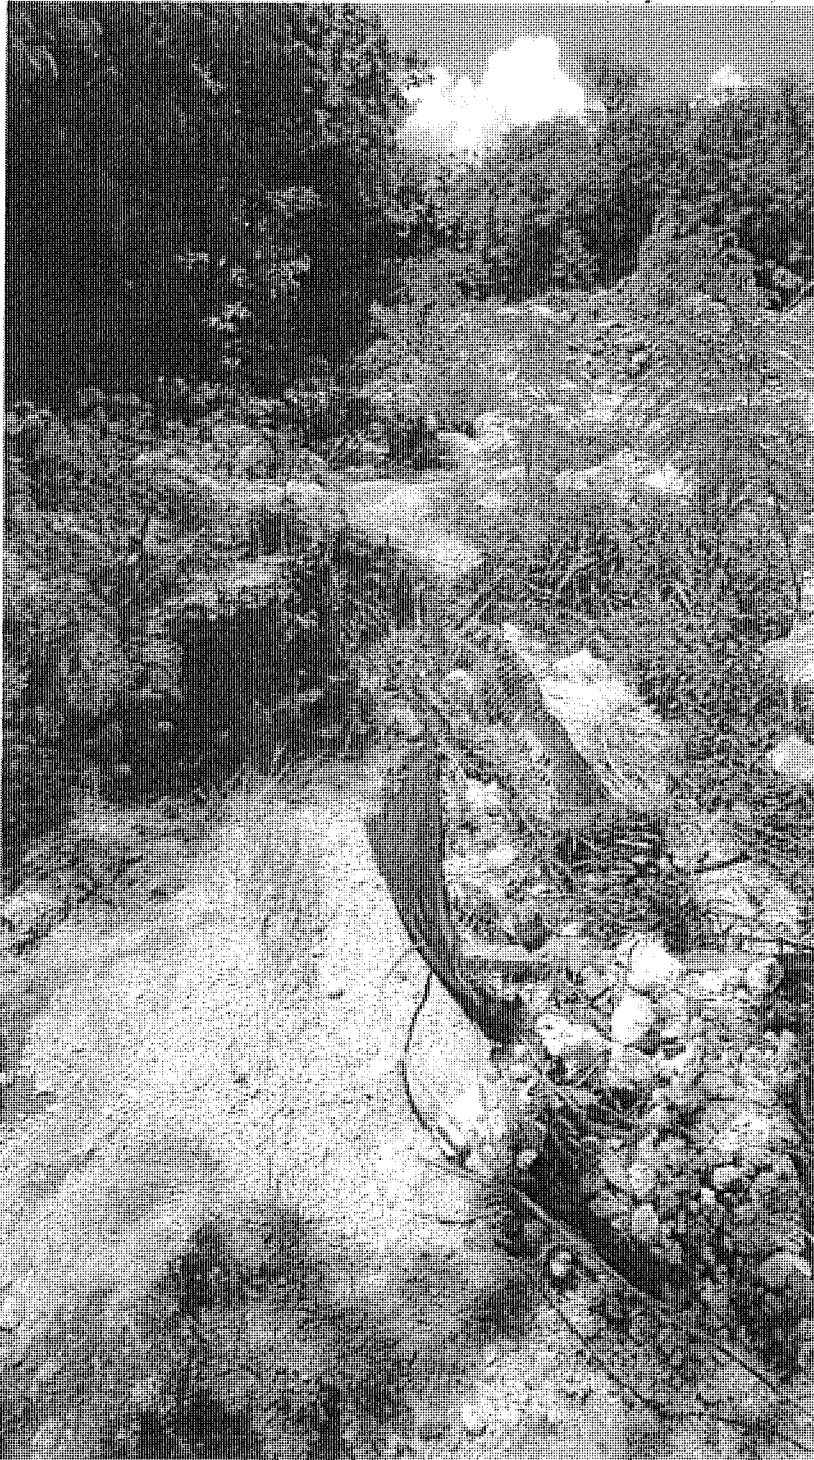
Another view of the sediment plume/delta formation resulting from the off-site discharge during the rain events the week of July 19. This photo is looking toward the off-site properties, headed downhill roughly in the direction of Marbo Cave. (July 28, 2021)

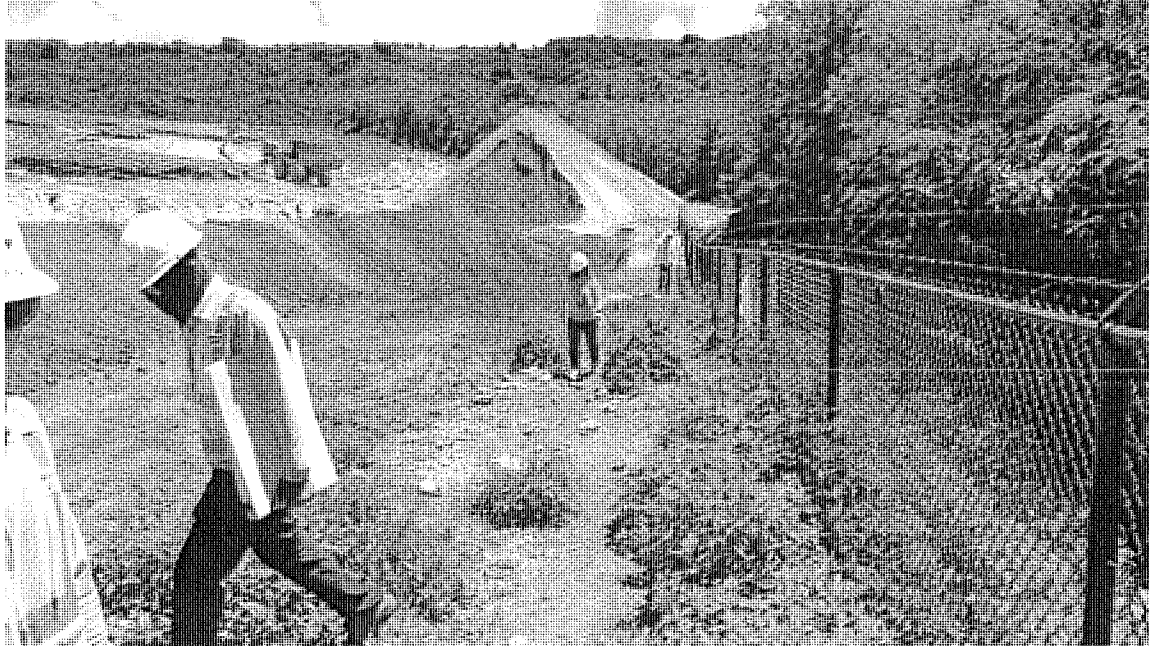
View toward Pond 5B location. The graded area to the right of the earthen embankment is the base of the permanent pond embankment, which Samsung had not yet begun to install. (July 28, 2021)

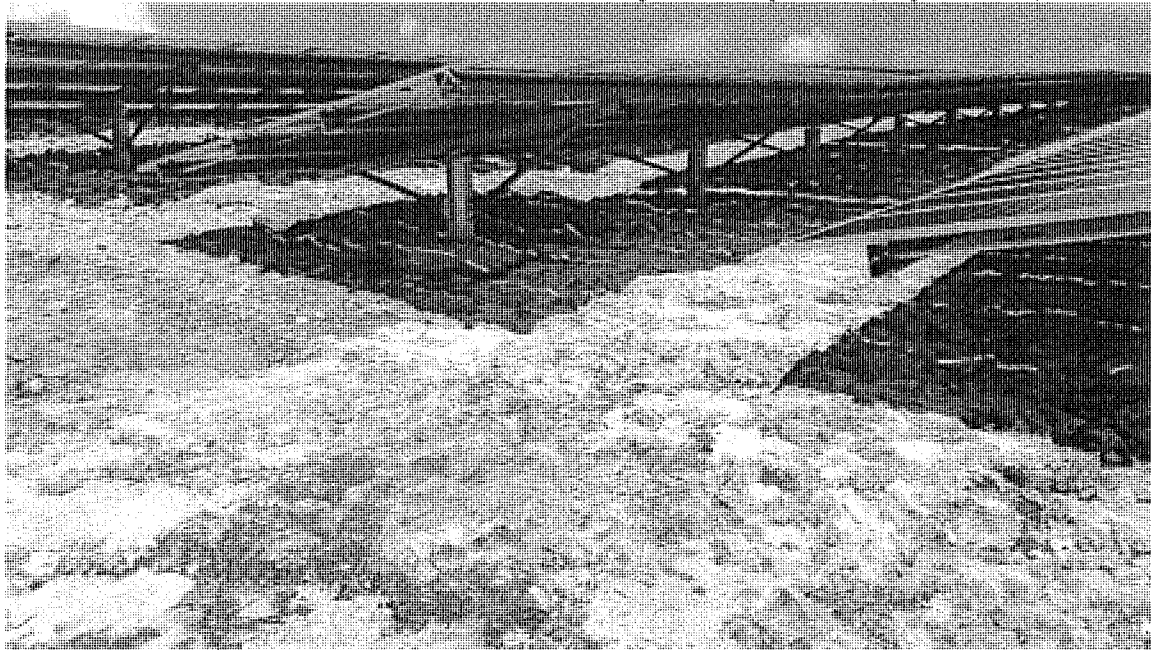
We observed extensive scouring and erosion of almost the entire upland project area above the Pond 5 area, with the ground surface beneath the solar panels visibly scoured down to bare limestone, with only thin deposits of sand and other sediments showing the direction that runoff had taken during the heavy rains the week before.

A partial view of the uphill project area which contributed to the discharge of runoff the week of July 19. Soil and fill material has been scoured from an area several hundred feet wide, leaving bare limestone bedrock in much of the area covered by the solar panels. (July 28, 2019)

- I recommended that Samsung take active steps to begin re-vegetating the site to stabilize the soils, which will reduce both runoff volume and the quantity of sediment that accumulates in the ponds.

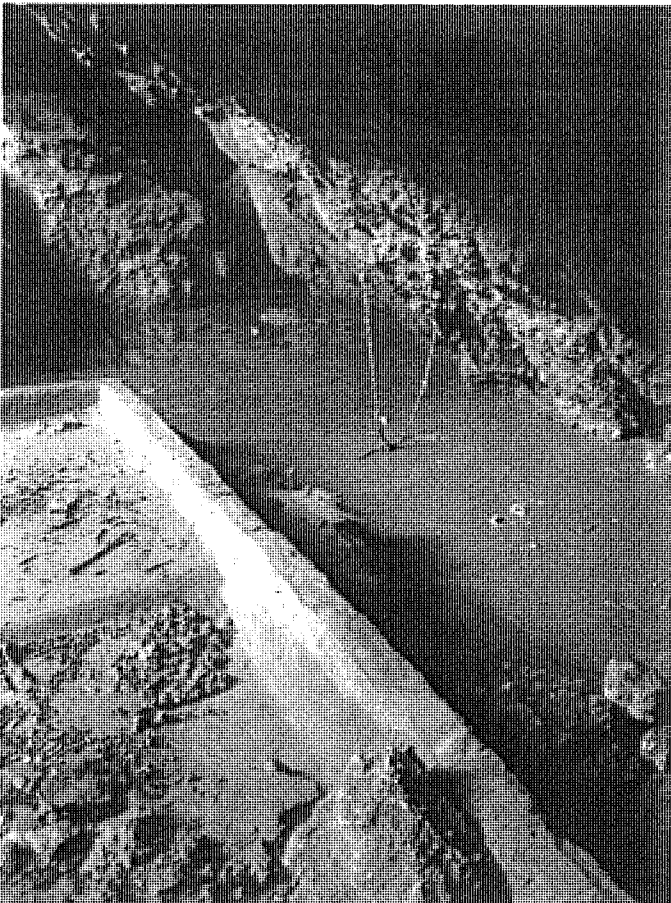
Photograph 12. Marbo Cave platform and center pool, 072821.
