27 KEPCO MANGILAO SOLAR, LLC and  
28 SAMSUNG E&C AMERICA, INC.,

)  
) DECLARATION OF COUNSEL FOR  
) DEFENDANT SAMSUNG E&C  
) AMERICA, INC. RE: MOTION FOR  
) JUDGMENT ON THE PLEADINGS

**Subject: Notice of Violation / Compliance Order / Penalty Order**

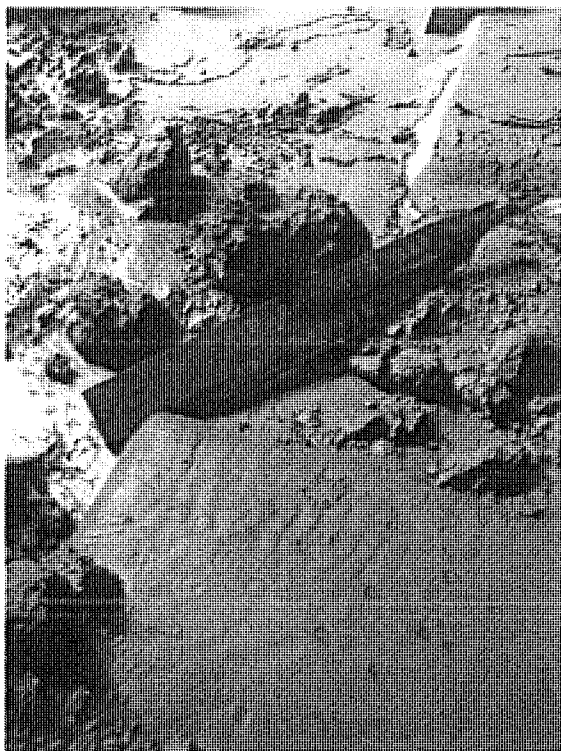
Photograph 13. Marbo Cave sediment and debris on platform, 072821.

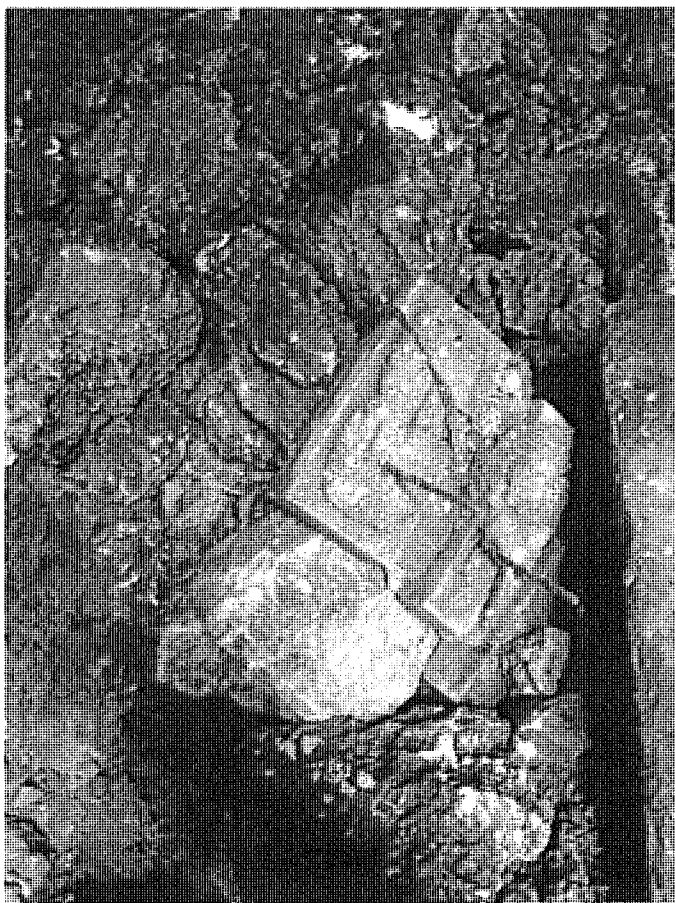
Photograph 14. Marbo Cave stair pieces, 072821.

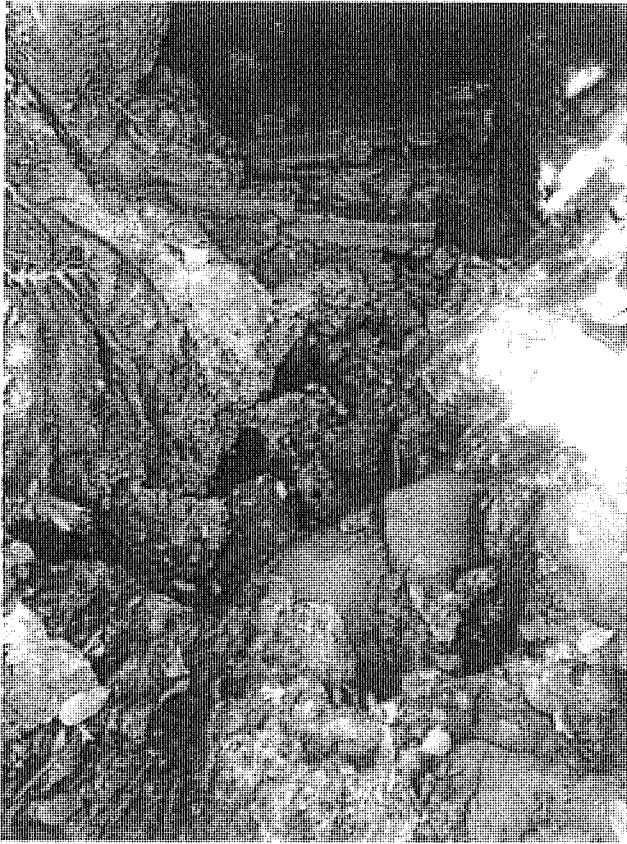
Photograph 15. Marbo Cave eroded steps looking down from entrance, 072821.

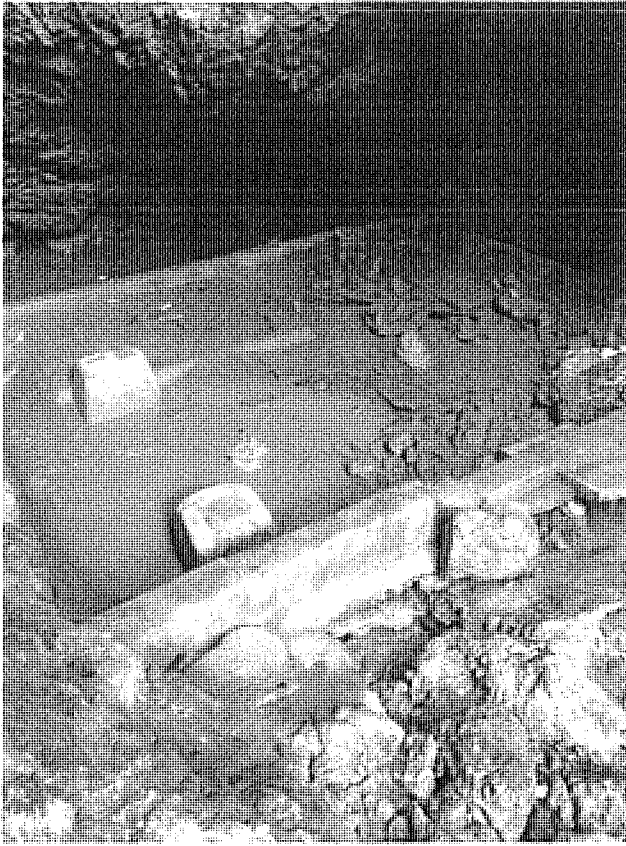
Photograph 17. Marbo Cave platform close-up w/ sediment and debris, 072821.

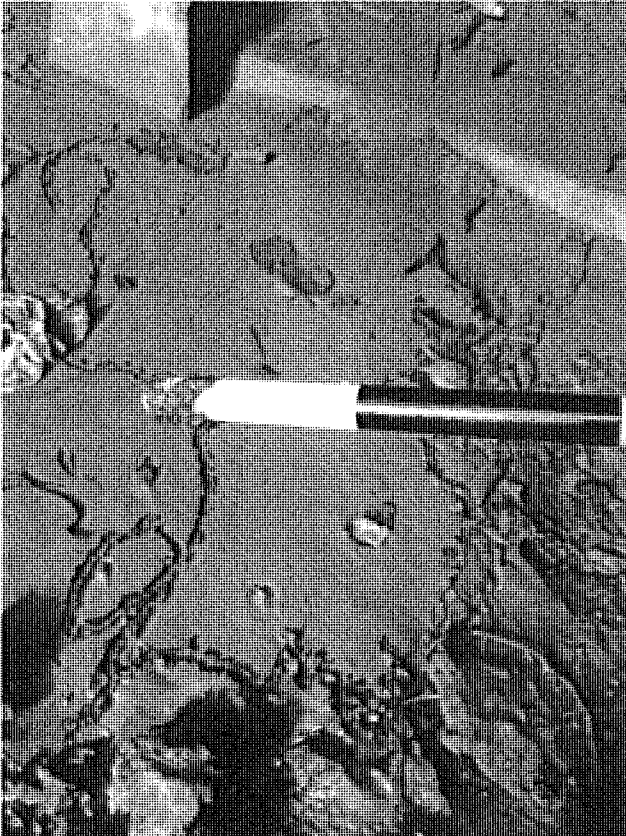
Photograph 18. Marbo Cave platform close-up approximate depth of sediment, 072821.

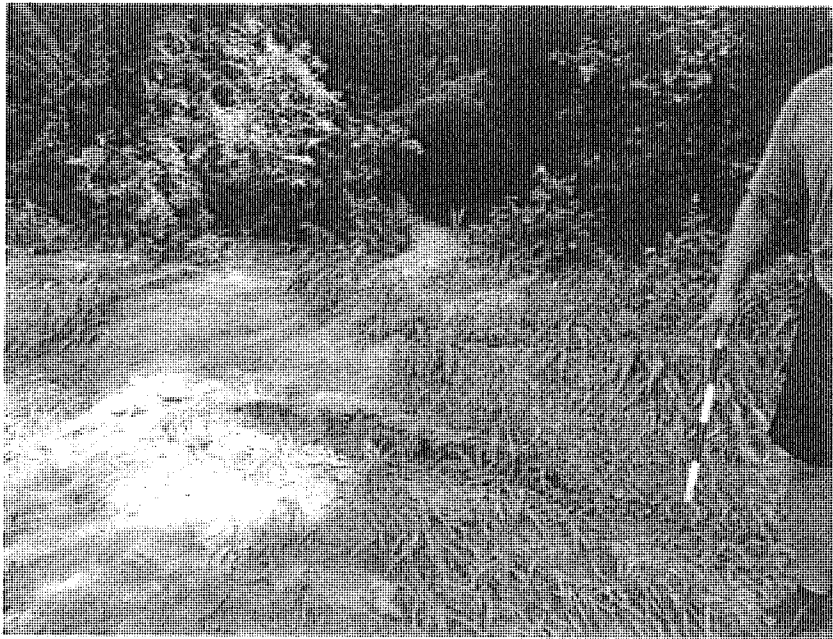
Photograph 19. Marbo Cave erosion area near opening, 072821.

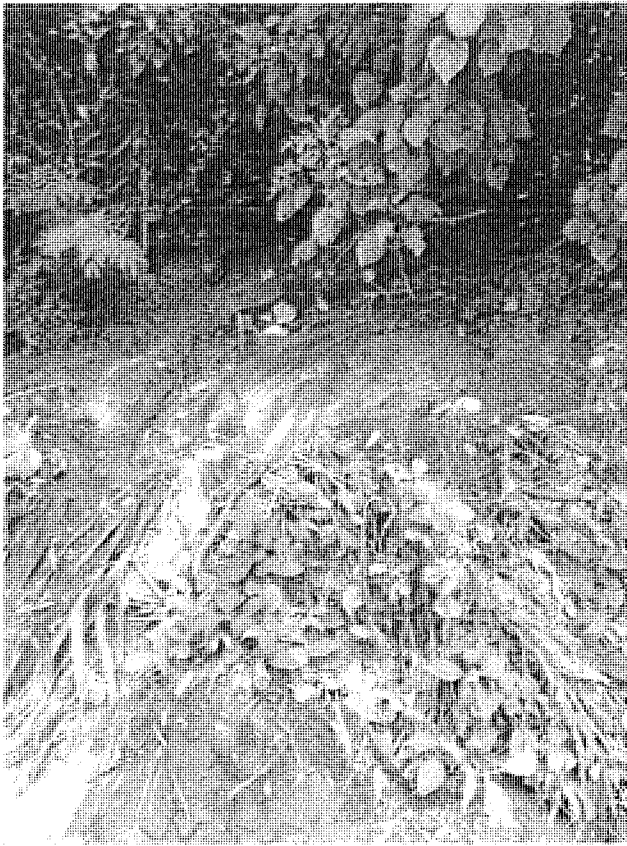
Photograph 21. Marbo Cave erosion area 2 near opening, 072821.

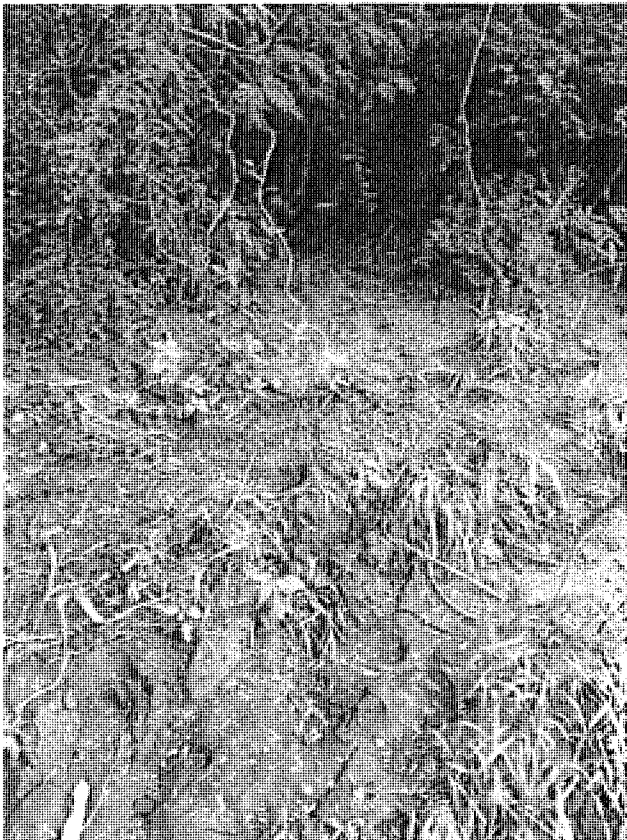
Photograph 22. Marbo Cave erosion area 3 near opening, 072821.

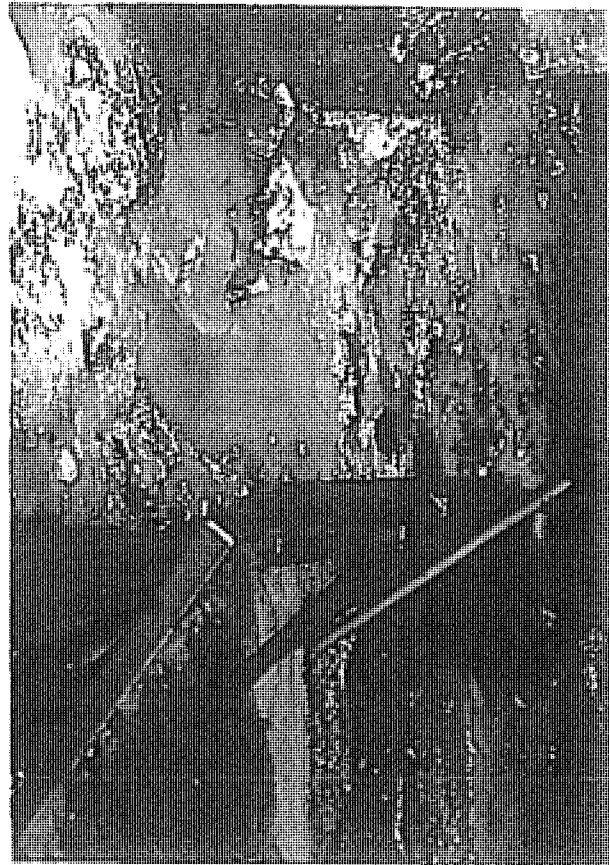
(08/02/2021) Silt Fences damaged by Soil Erosion

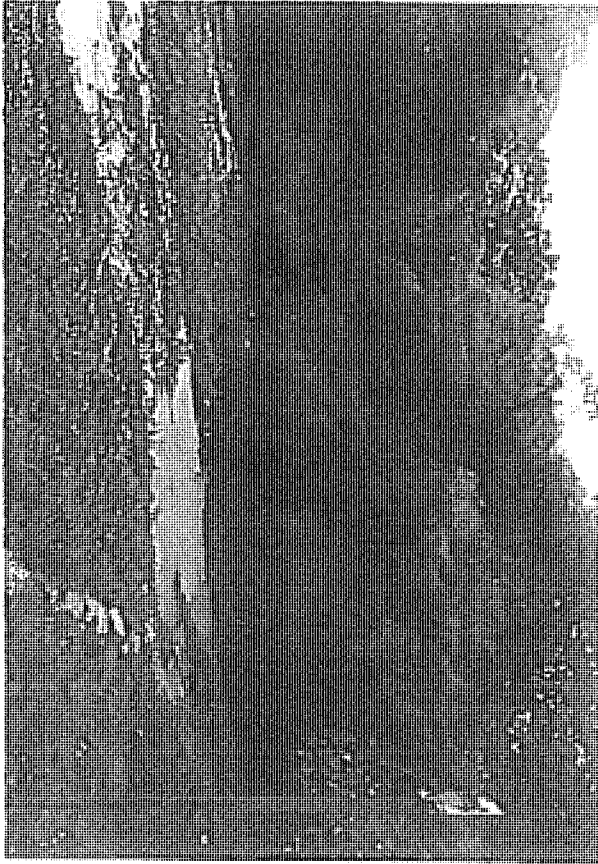
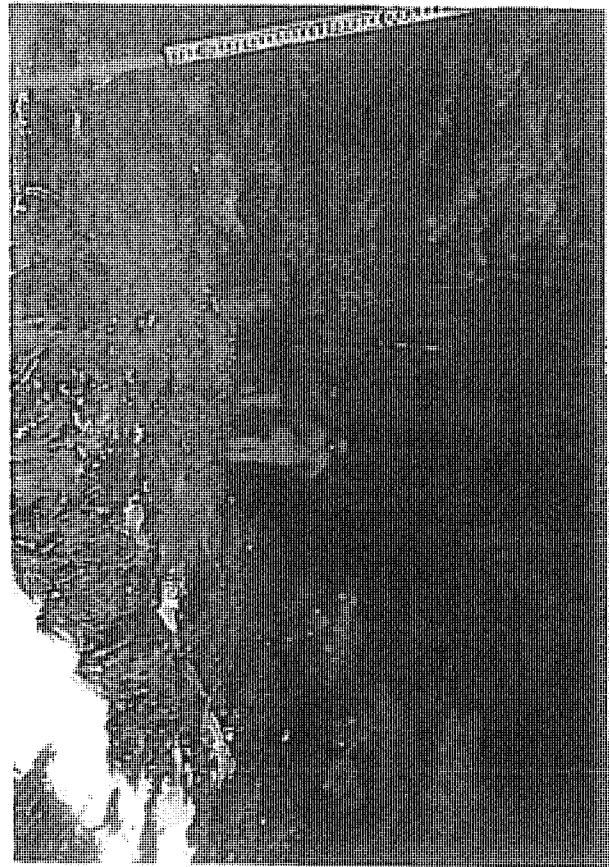
(08/02/2021) Topside area of the entrance into Marbo Cave damaged by the soil erosion

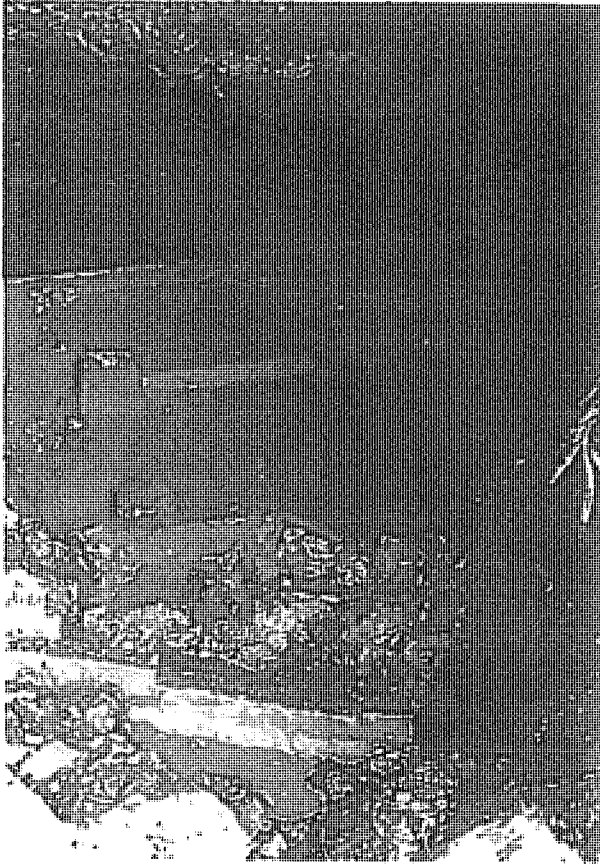
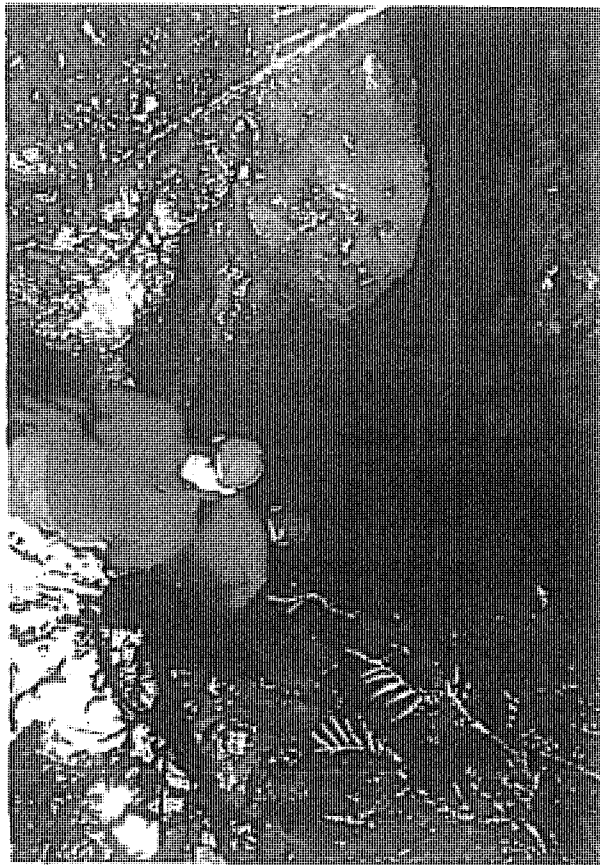
(08/02/2021) Marbo Cave damaged by soil erosion
